# Manhole Inspection Summary

Manhole # S05AA2020MH

**Location** Address: **5919 SIMMONDS AVE**

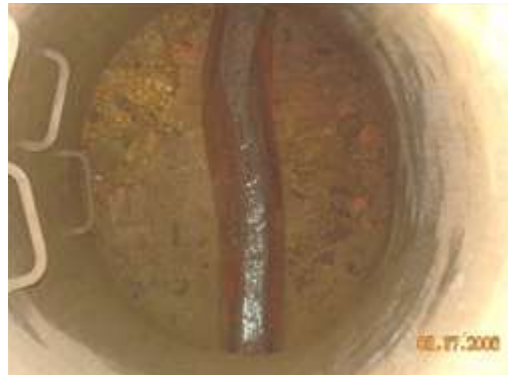
Top View

Bench debris.

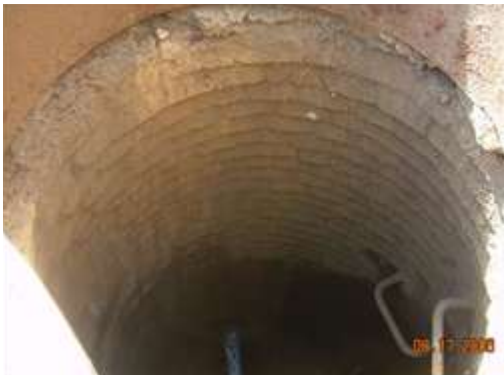
Defect

☒ **Leaks**

Condition: ☐ Sound ☐ Cracked ☐ Root Intrusion ☐ Loose Brick ☒ **Deteriorated**

Infiltration: ☐ None ☒ **Joint** ☐ Cracks ☐ Mortar ☐ Roots ☒ **Wall**

Infiltration: ☐ None ☐ Joint ☐ Cracks ☒ **Mortar** ☐ Roots ☒ **Wall**

Frame leaks. Adjustment deterioration and infiltration. Barrel infiltration.

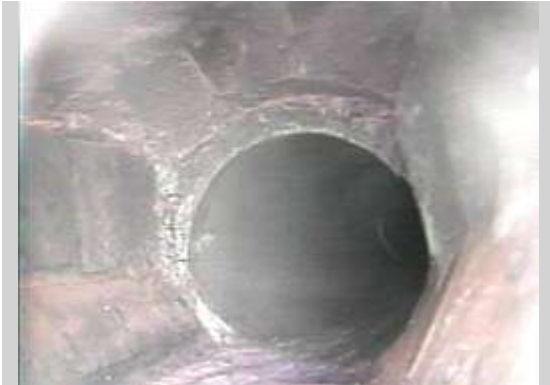
### 8 in. Circular Gravity Sewer Pipe Out @ 12 O'Clock

Infiltration: **Evidence** Pipe Seal Cond: **Cracked**
